# Inspection Report

Home Sweet Home!

# Accurate Inspections of NWFL, LLC

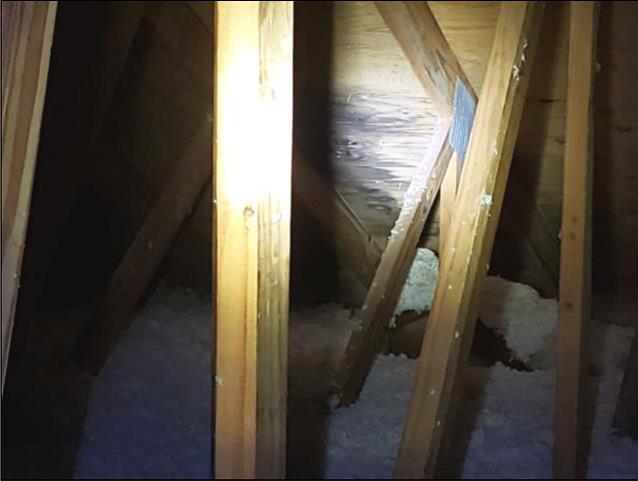
1.4 Item 1(Picture) front

**1.4** Several areas of wood rot observed at the attic (most likely from leaks). I am unable to determine if the leaks are new or have been corrected. I recommend monitor and repair as needed.

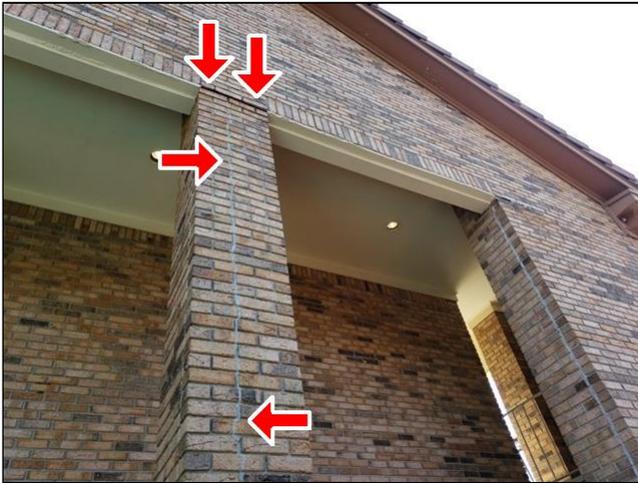
2.0 Item 1(Picture) left

**2.0** Cracks in brick observed at posts at the rear. Previous repairs observed. Lintels are rusted which may indicate failure. I recommend further inspection by a qualified licensed contractor to repair or replace as needed. Any structural repairs should be supervised by a qualified architect and/or engineer.

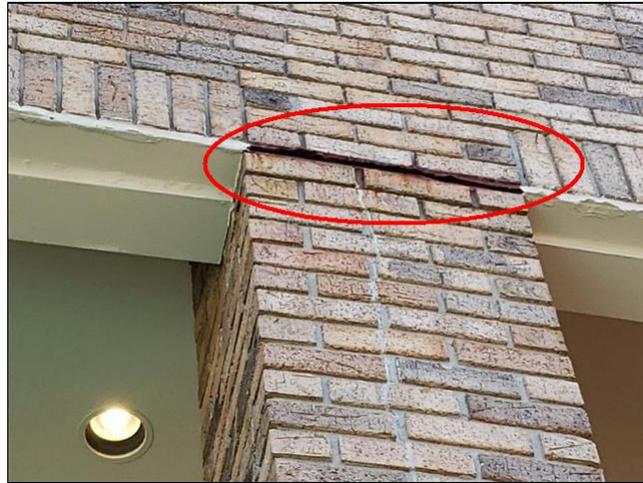
2.0 Item 2(Picture) left

Cracks in brick observed at posts at the rear. Previous repairs observed. Lintels are rusted which may indicate failure. I recommend further inspection by a qualified licensed contractor to repair or replace as needed. Any structural repairs should be supervised by a qualified architect and/or engineer.

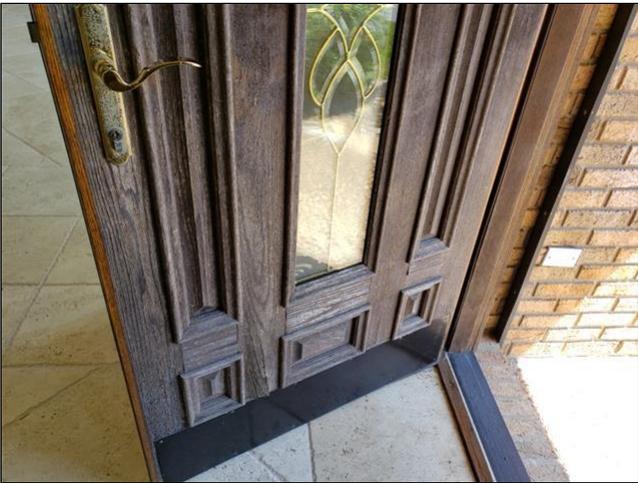
2.1 Item 1(Picture) front door

**2.1** Front door is deteriorated and delaminating. I recommend repair or replace as needed.

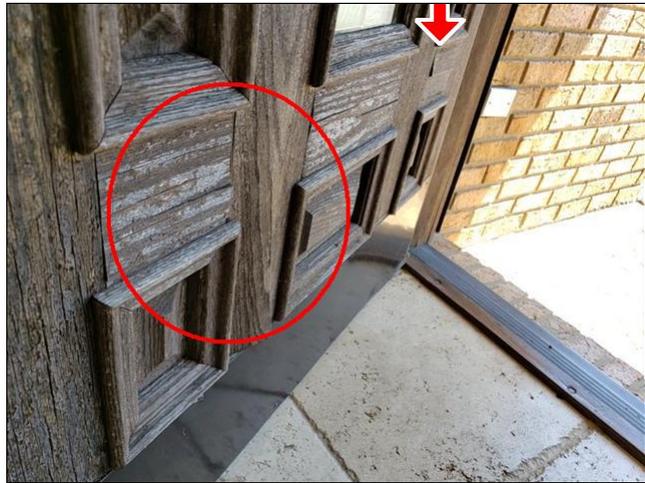
2.1 Item 2(Picture) front door

Front door is deteriorated and delaminating. I recommend repair or replace as needed.

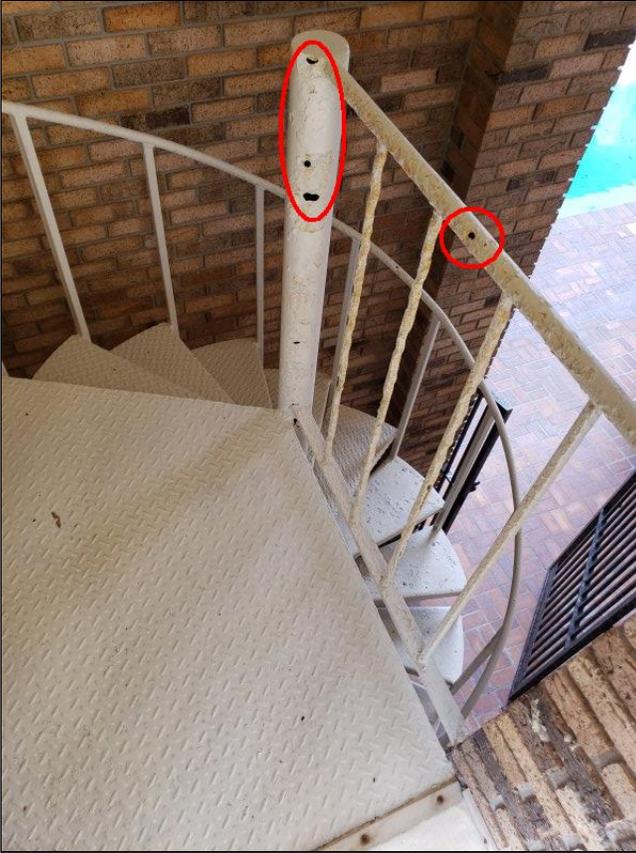
2.3 Item 1(Picture) front/left

2.3 Spiral stairs at the exterior are rusted and deteriorated. General replacement is likely necessary. Injury could result if not repaired or replaced. I recommend repair or replace as necessary.

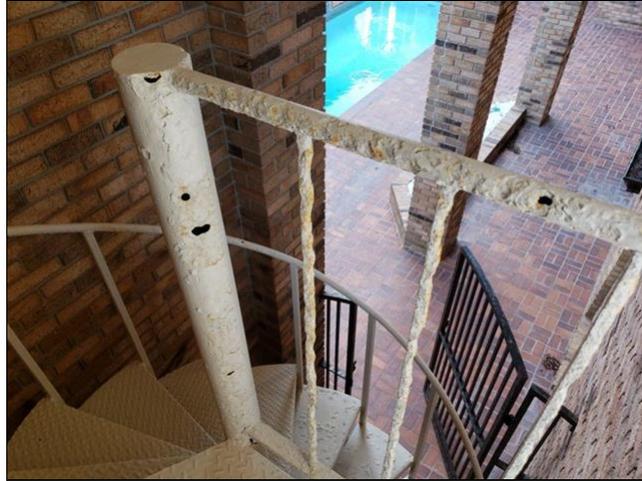
2.3 Item 2(Picture) front/left

Spiral stairs at the exterior are rusted and deteriorated. General replacement is likely necessary. Injury could result if not repaired or replaced. I recommend repair or replace as necessary.

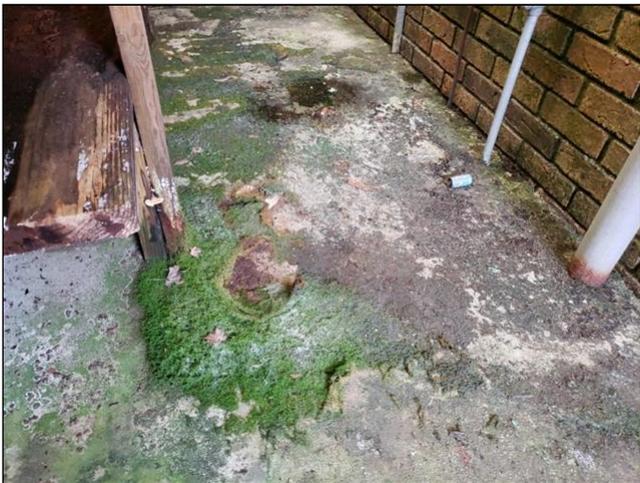
2.4 Item 1(Picture) rear

**2.4** Exterior closet at the rear does not drain properly. Ponding water should never exist around electrical main shut off. This is a safety issue that should be corrected. I recommend repair as necessary.

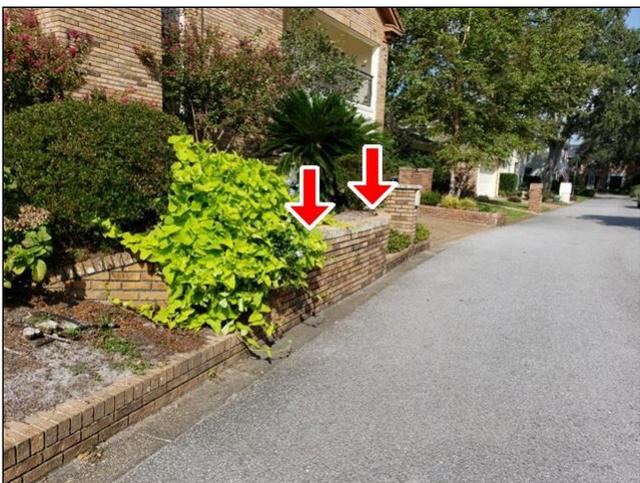
2.8 Item 1(Picture) right

**2.8** (1) Structural cracks observed in the brick retaining wall at the right side near garage. I recommend repair or replace as needed.

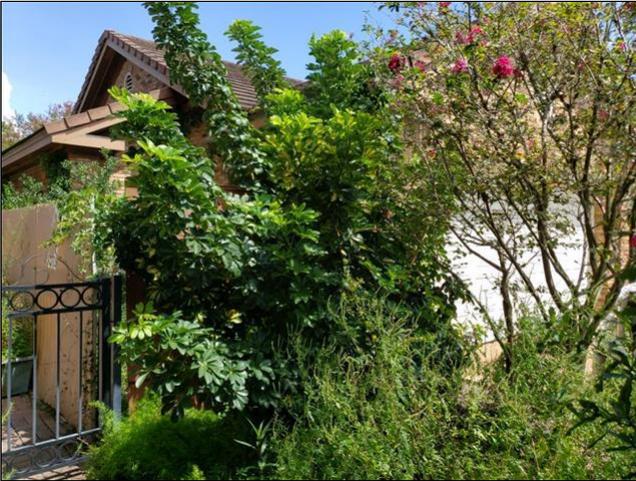
2.8 Item 4(Picture) guest house - garage

(2) Gate at the rear is blocked by vegetation. I recommend trim as necessary.

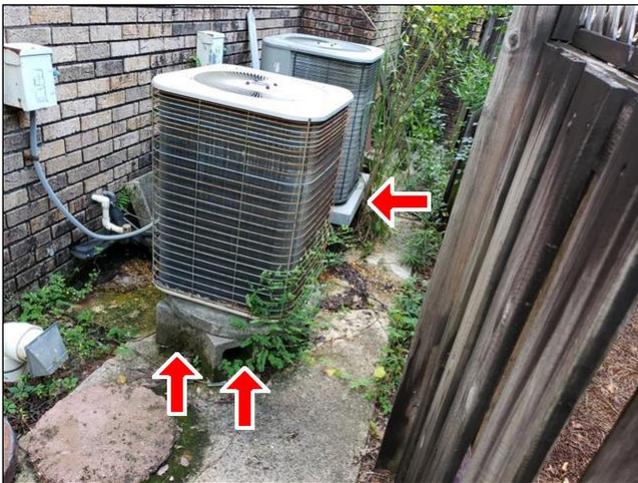
4.3 Item 1(Picture)

**4.3** Compressor units should be installed on a permanent pad (at least 2 inches above grade) and not loose bricks. May not be cost effective to replace at this time but I recommend following manufacturer recommendations and installation instructions and follow the FBC (Florida Building Code). This is for your information.

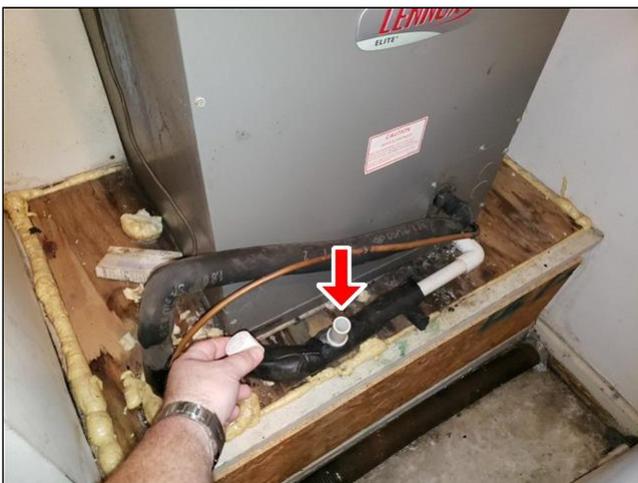
4.6 Item 1(Picture) garage - air handler

**4.6** (1) The air handler is equipped with a clean out port which will allow for monthly maintenance of the condensation drain line to the exterior. This is especially important during peak summer months. This is a maintenance item and for your information.

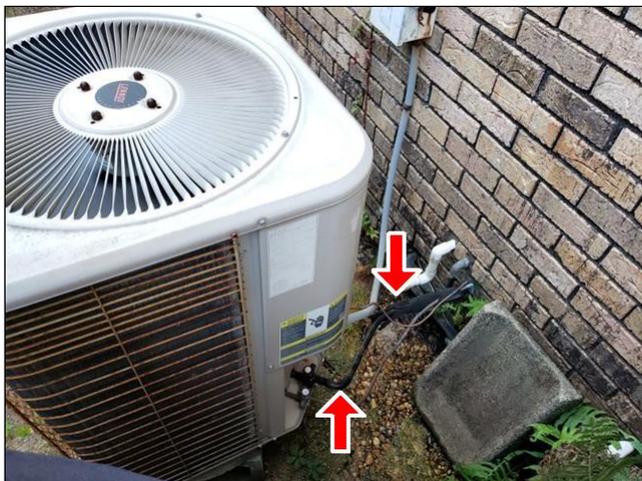
4.6 Item 2(Picture) rear-condenser

(2) The foam sleeve on suction line is missing foam sleeve in area(s) at outside unit. Missing foam on suction line can cause energy loss. I recommend replace foam sleeve as needed.

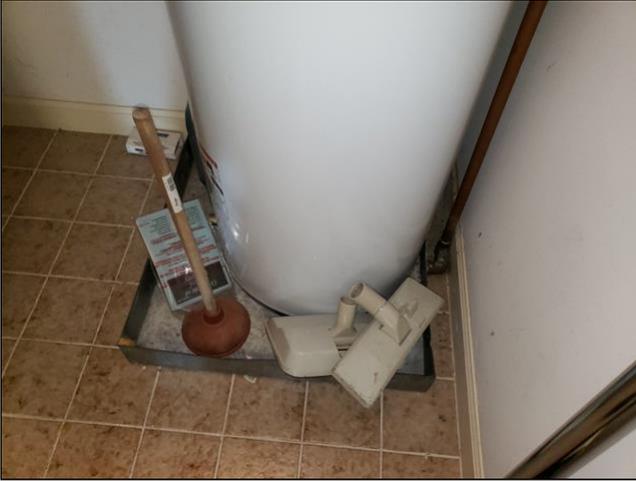
5.2 Item 1(Picture) hall closet upstairs

**5.2** Drain pan for water heater upstairs at the hall closet is not plumbed to the exterior. Probably not cost effective to repair at this time but I recommend installing drain pipe with next water heater if installed at the interior. This is for your information.

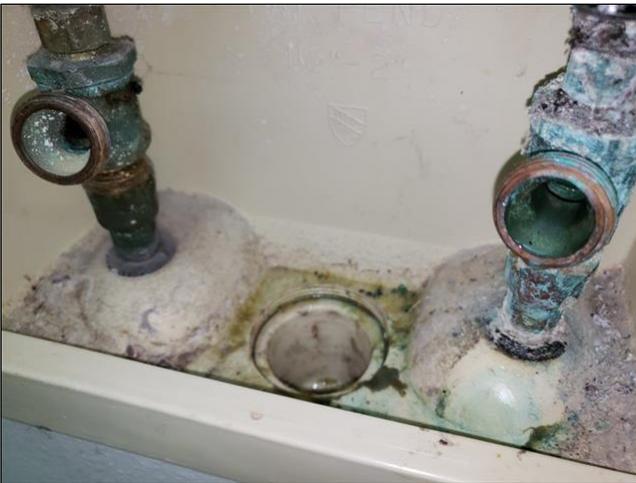
5.3 Item 1(Picture)

**5.3** (1) Cold faucet for washer at laundry room downstairs leaks or drips continuously. I recommend repair or replace as needed.

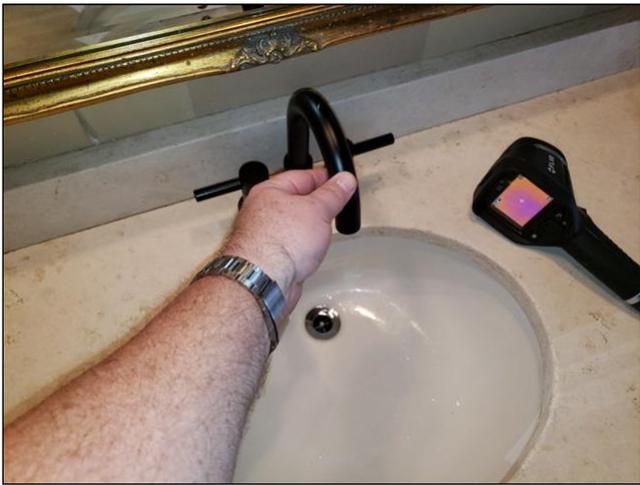
5.3 Item 3(Picture) guest bath upstairs

(2) Sink faucet is loose at the guest bath upstairs. I recommend repair or replace as needed.

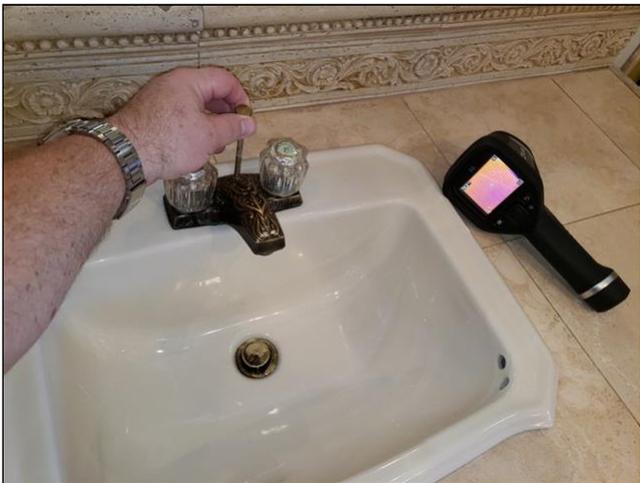
5.4 Item 1(Picture) master bath

5.4 Several stop valves do not work properly or are missing. I recommend repair or replace as needed.

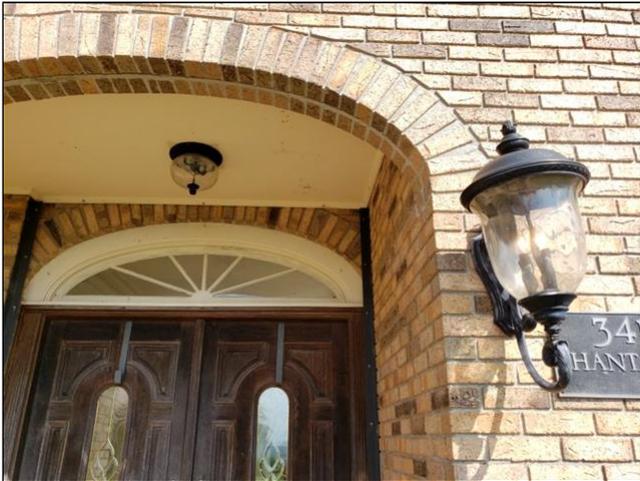
6.3 Item 1(Picture)

6.3 (1) Several light fixtures at the interior and exterior are inoperable. I recommend replacing bulbs. Several light bulbs are missing. If replacing bulbs does not work a qualified licensed electrician should correct as needed.

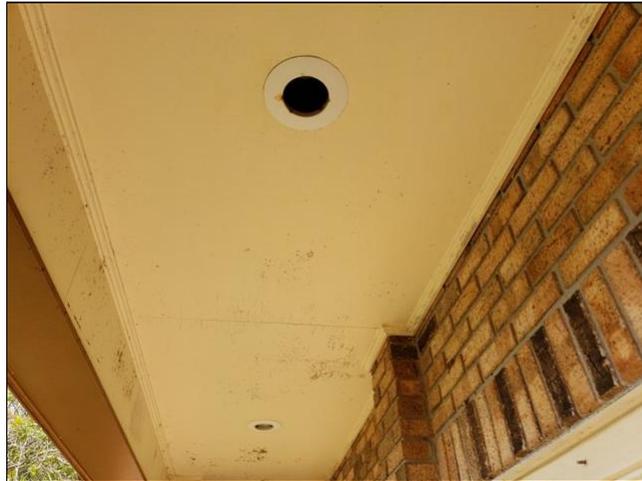
6.3 Item 2(Picture)

(1) Several light fixtures at the interior and exterior are inoperable. I recommend replacing bulbs. Several light bulbs are missing. If replacing bulbs does not work a qualified licensed electrician should correct as needed.

(2) Covers are missing for electrical outlets in floor and several other areas. I recommend repair as necessary. Any repairs that involve electrical wiring should be done by a qualified licensed electrician.

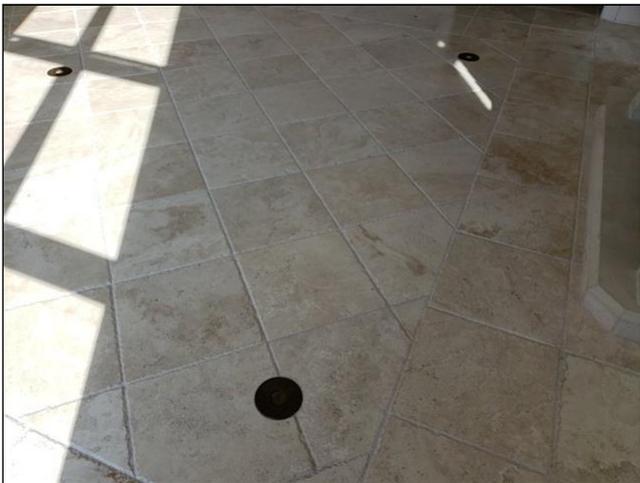
6.3 Item 4(Picture) living room

(2) Covers are missing for electrical outlets in floor and several other areas. I recommend repair as necessary. Any repairs that involve electrical wiring should be done by a qualified licensed electrician.

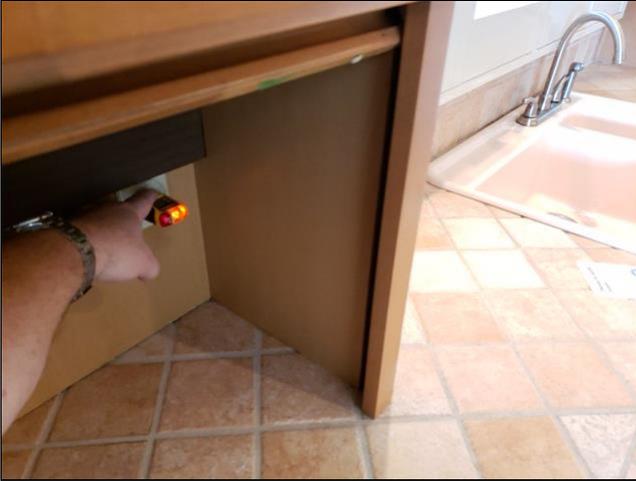
6.5 Item 1(Picture) kitchen

**6.5** GFCI (ground fault circuit interrupter) outlets observed at the exterior in areas but are missing at kitchen and some bathrooms. This is a safety issue that should be corrected by a qualified licensed electrician.

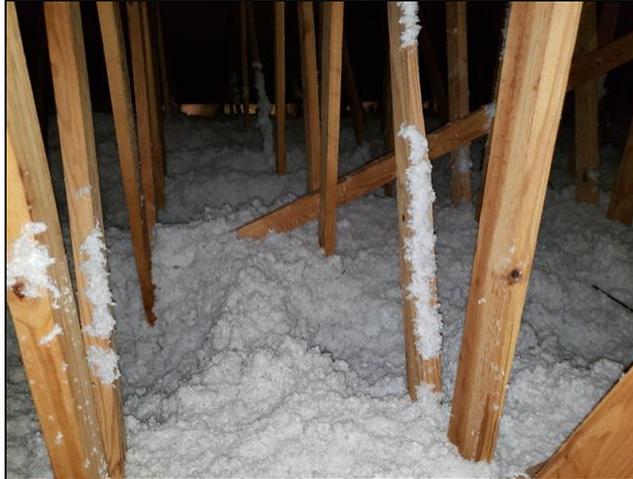
attic - insulation

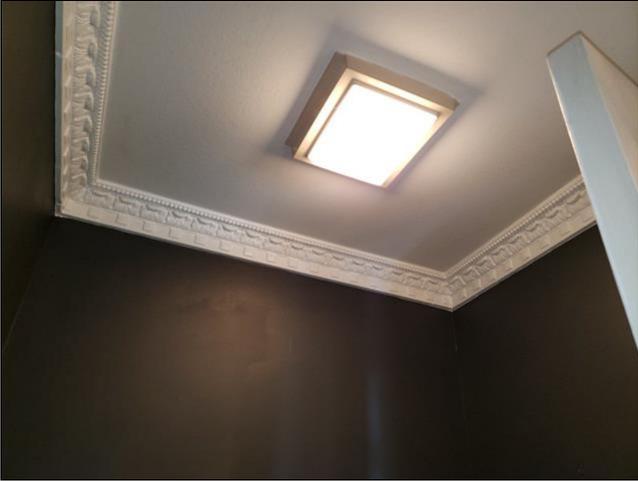
8.3 Item 1(Picture) hall bath

**8.3** Several bathroom exhaust fans are not working properly. Lights for several fans at bathrooms are not working. I recommend repair or replace as needed. Any repairs that involve electrical wiring should be done by a qualified licensed electrician.

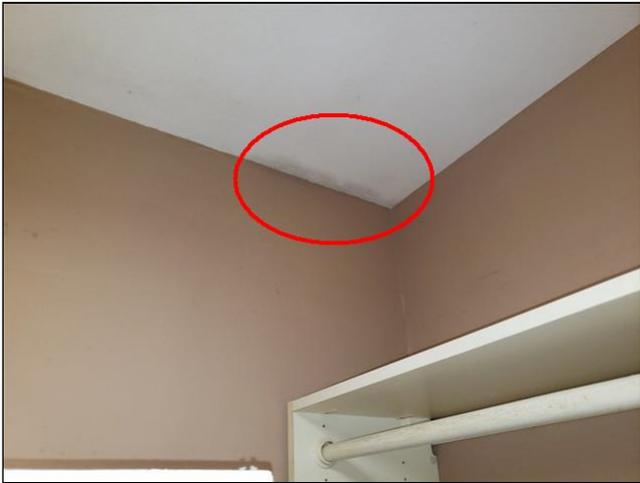
9.0 Item 1(Picture) master closet

**9.0** (1) Signs of organic growth are present on ceiling in several areas upstairs. We did not inspect, test or determine if this growth is or is not a health hazard. The underlying cause is moisture or dampness. I recommend you contact a qualified licensed mold assessor for investigation as necessary.

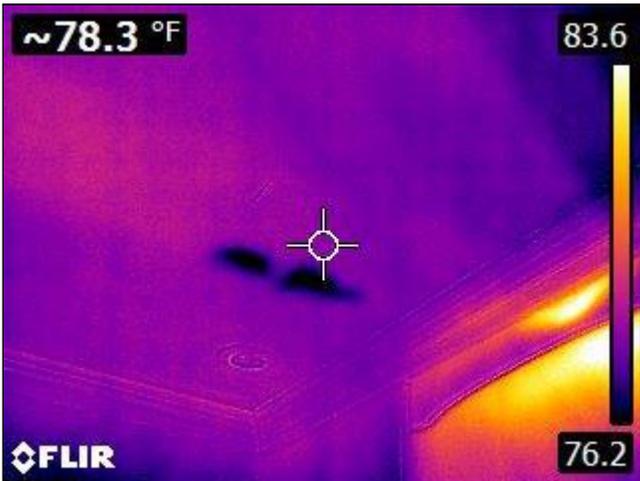
9.0 Item 13(Picture) kitchen

(2) An anomaly was discovered at the kitchen ceiling after running plumbing outlets upstairs. FLIR infrared thermal imaging camera revealed an area of concern. FLIR moisture meter detected moisture (over 15%). I recommend find source of leak and repair or replace as necessary.

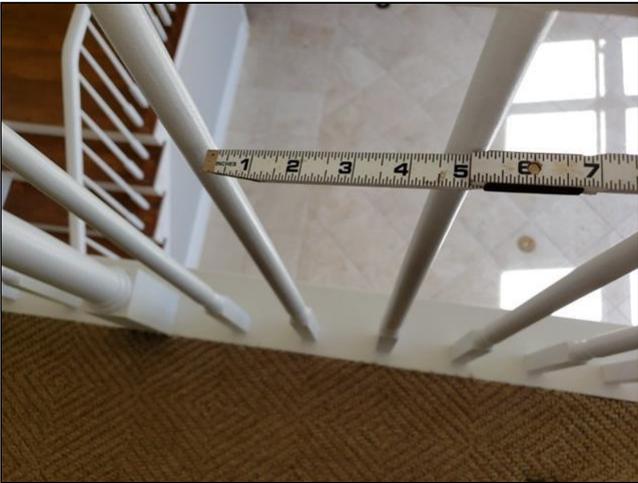
9.3 Item 1(Picture)

**9.3** The hand/guard rail for the upstairs pickets are spaced too far apart for safety. Spacing more than 4 inches apart could allow an adult, child or pet to fall through. The maximum space between pickets should be four inches. I recommend repair or replace as necessary for safety.

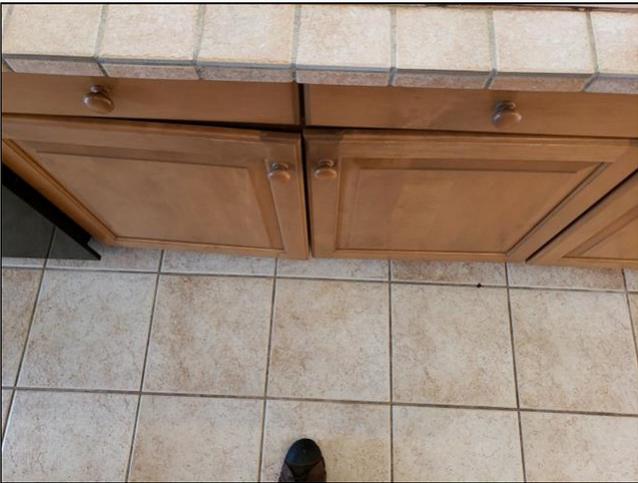
9.4 Item 1(Picture)

**9.4** Cabinet doors underneath kitchen sink do not shut properly. I recommend repair or replace as needed.

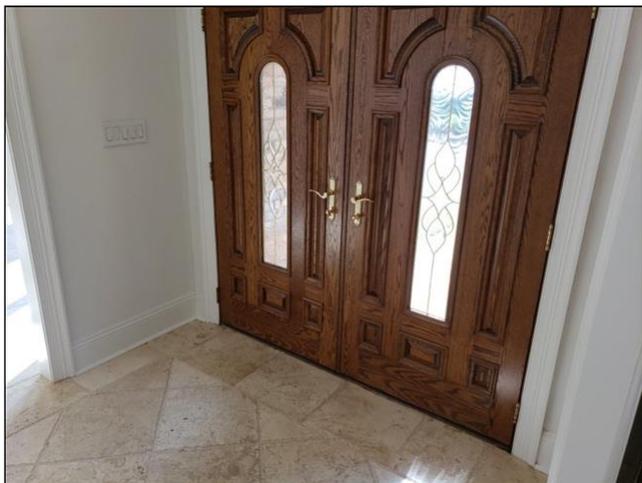
9.5 Item 1(Picture)

**9.5** Several door stops are missing. I recommend replace as needed.

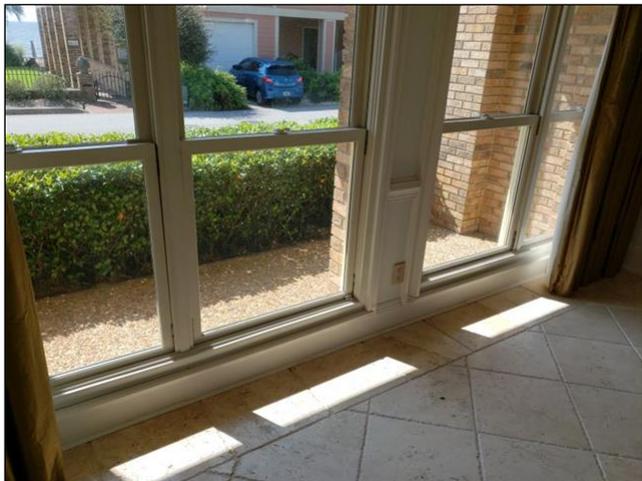
9.6 Item 1(Picture) dining room

**9.6** Several windows will not stay up without a prop. Window at the dining room will not shut and/or lock properly. I recommend repair or replace as necessary.

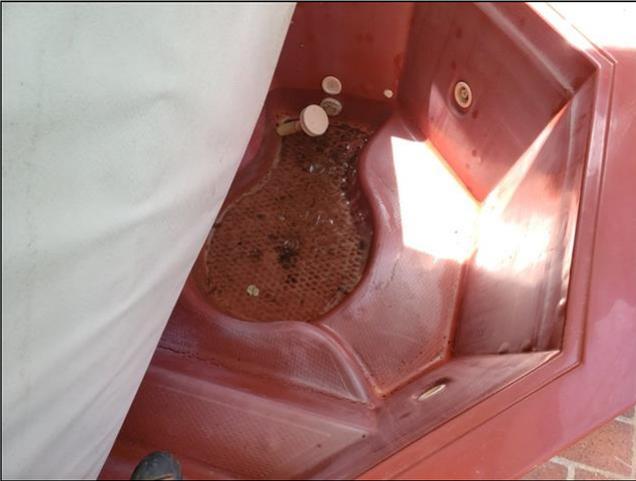
12.0 Item 1(Picture) hot tub

**12.0** (1) Hot tub was empty of water at time of inspection. This is for your information.

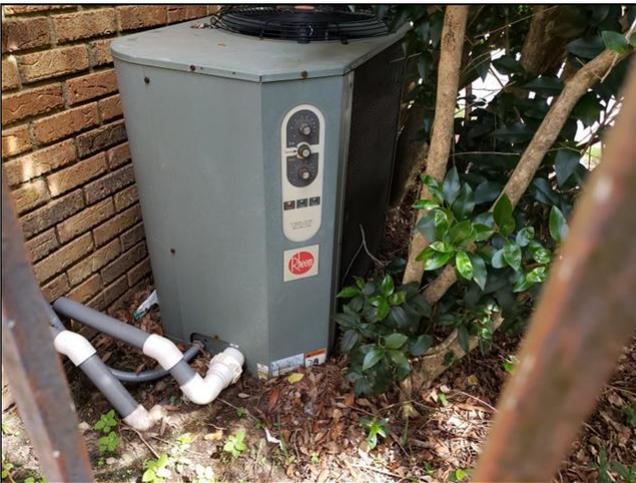
12.0 Item 2(Picture)

(2) Heat pump should be on a 3.5 inch concrete pad, or other approved material (should be at least 2" above grade). May not be cost effective to replace at this time, but I recommend following manufacturer installation instructions with next unit.

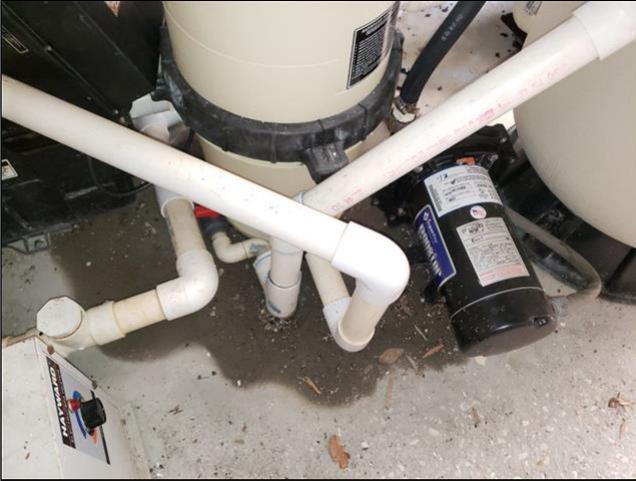
12.0 Item 3(Picture)

(3) Leak observed at pool pump. I was unable to determine source of leak. I recommend further inspection by a qualified licensed pool tech to repair or replace as necessary.

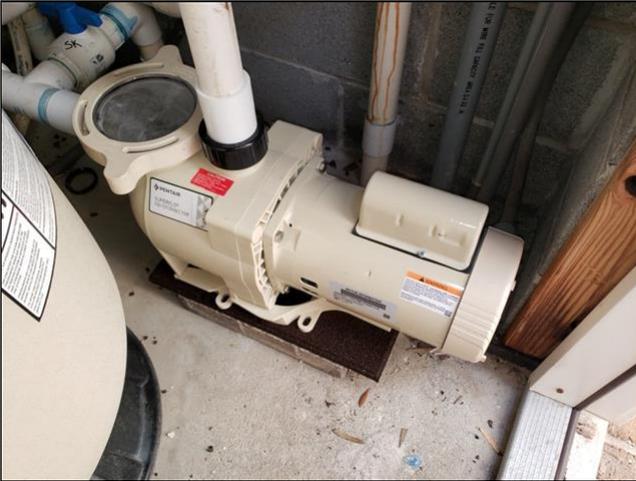
12.4 Item 1(Picture)

**12.4** Ground wire for pool pump and boost pump is missing. This is a safety issue that needs to be corrected. I recommend further inspection by a qualified licensed electrician to correct as necessary for safety.

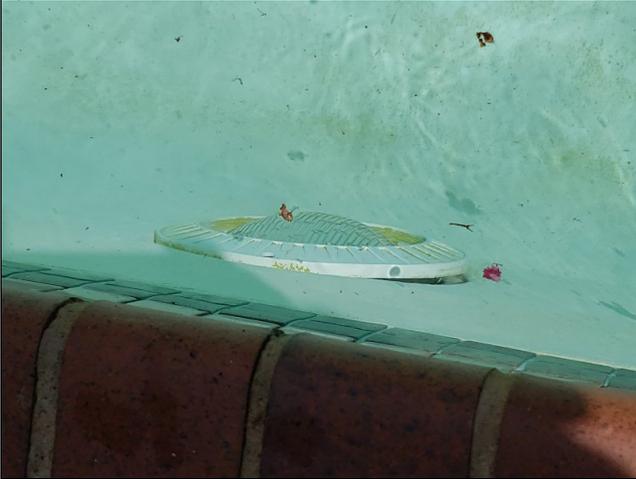
12.19 Item 1(Picture)

**12.19** Electric pool light is loose. I recommend further inspection by a qualified licensed electrician to correct as necessary.

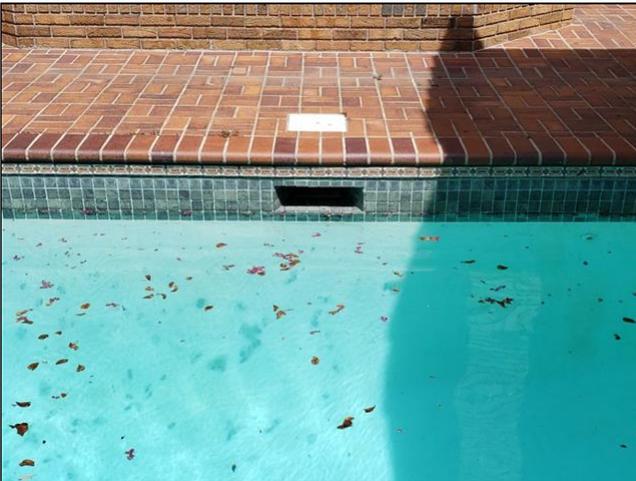
12.20 Item 1(Picture)

**12.20** Water level is low. I recommend add water for proper operation.

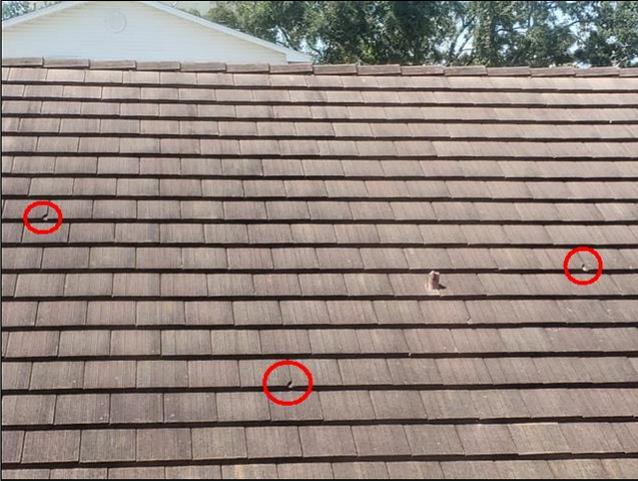
13.2 Item 1(Picture)

**13.2** Several tiles are cracked and damaged. I recommend further inspection by a qualified licensed roofing contractor to repair or replace as necessary.

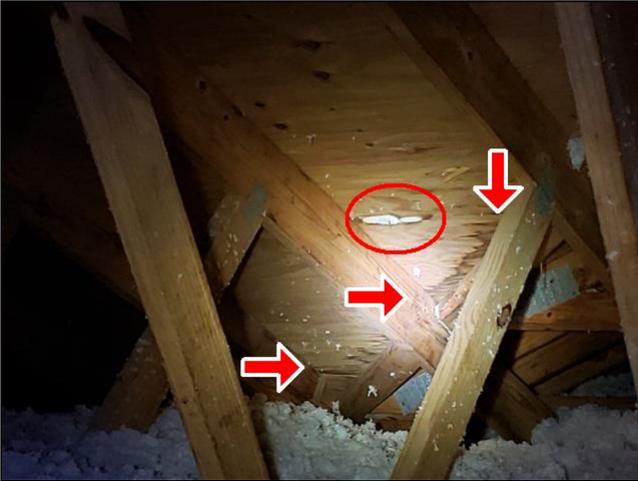
13.3 Item 1(Picture) over garage

**13.3** Wood rot and organic growth observed at the roof sheathing over garage. I recommend further inspection by a qualified licensed contractor to find source of leak and repair or replace as necessary.

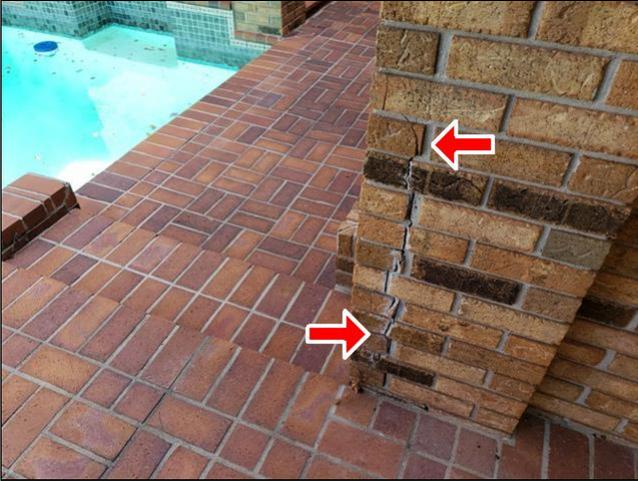
13.4 Item 1(Picture) front

**13.4** Brick is cracked and damaged at the front of guest house (facing pool). I recommend further inspection by a qualified licensed contractor to repair or replace as necessary.

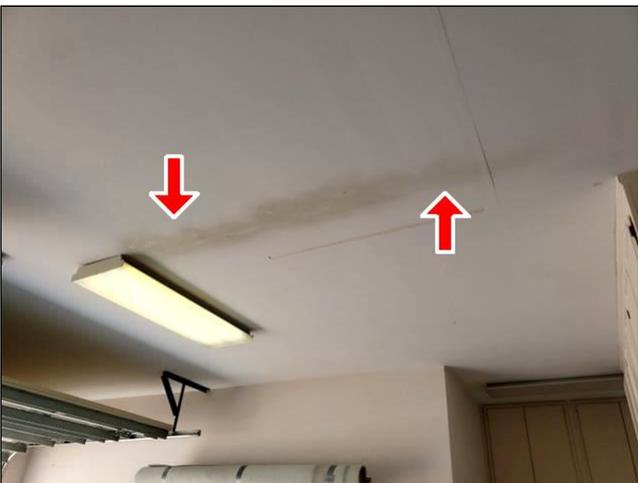
13.5 Item 1(Picture) guest house garage

**13.5** The sheetrock on the ceiling reveals a water stain indicating a leak did or still exists at the garage. The FLIR IR thermal imaging camera and moisture meter were used and meter did not indicate an active leak. I recommend monitor and repair as needed.

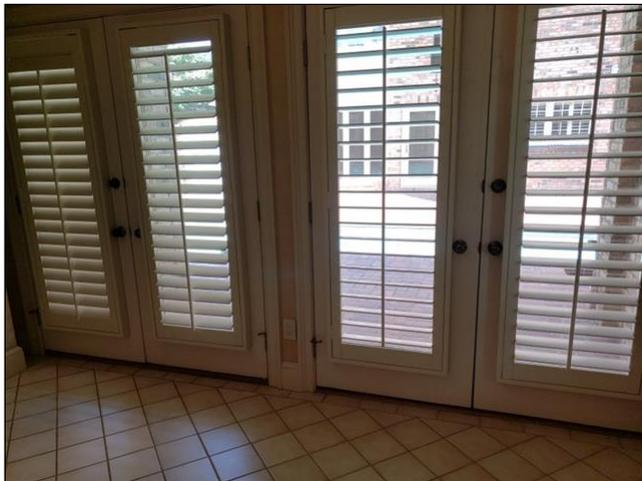
13.6 Item 1(Picture)

**13.6** Door knobs for exterior doors at the living room do not lock properly. I recommend repair or replace as needed.

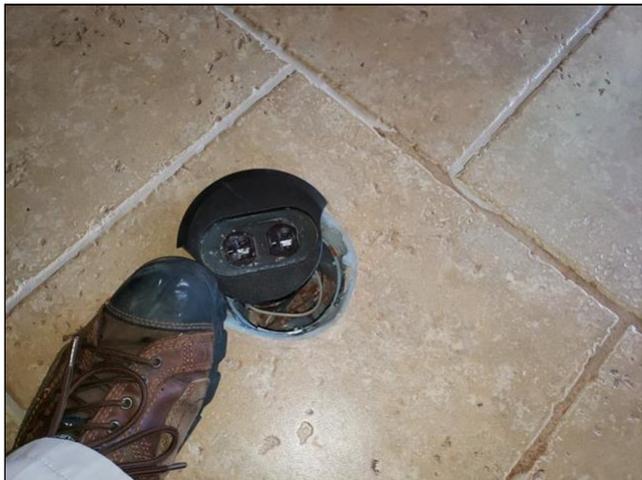
13.11 Item 1(Picture) guest house

(2) Electrical outlet in the floor at the living room is loose. Several wall outlets are loose in wall. Loose wiring is considered a hazard until repaired. I recommend further inspection by a qualified licensed electrician to correct as necessary.

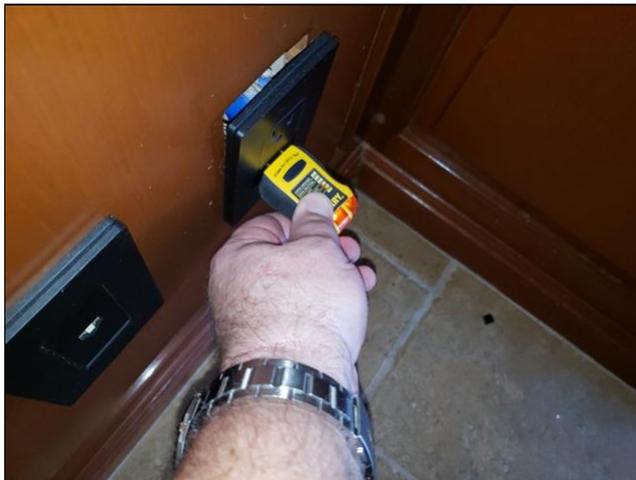
13.11 Item 2(Picture) guest house

**13.11** (1) Several light fixtures at the interior and exterior are inoperable. I recommend replacing bulbs. If replacing bulbs does not work a qualified licensed electrician should correct as needed.

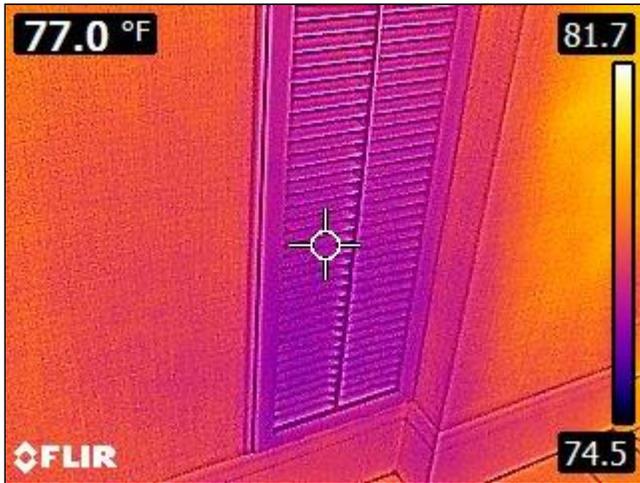
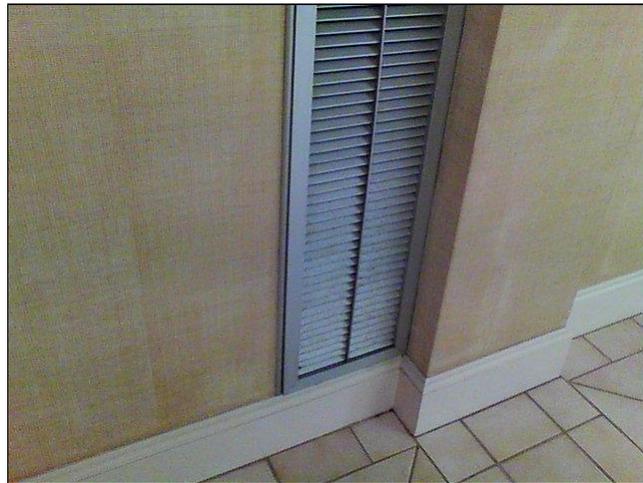
13.14 Item 1(Picture) return temp - 77F

**13.14** The ambient air test was performed by using thermometers (IR thermal imaging camera) on the air handler of heat pump in cool mode to determine if the difference in temperatures of the supply and return air are between 14 degrees and 22 degrees which indicates that the unit is cooling as intended. The supply air temperature on your system read 71 degrees, and the return air temperature was 77 degrees. This indicates that the unit is **NOT** cooling properly and a qualified licensed Heat/Air contractor should inspect for cause or problem.

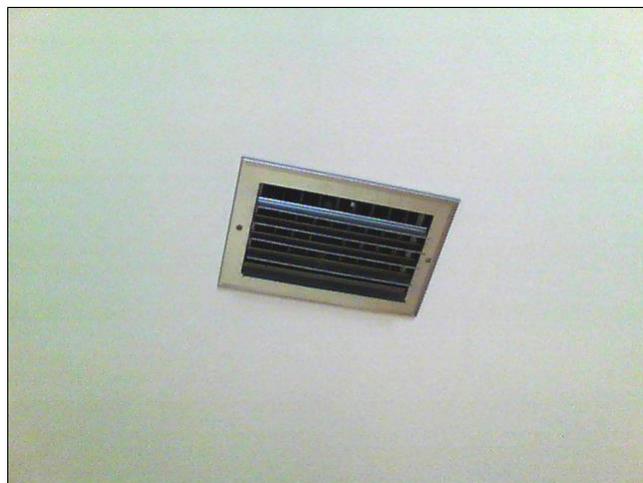
13.14 Item 3(Picture) A/C supply temp - 71F

13.14 Item 4(Picture) A/C supply temp - 71F

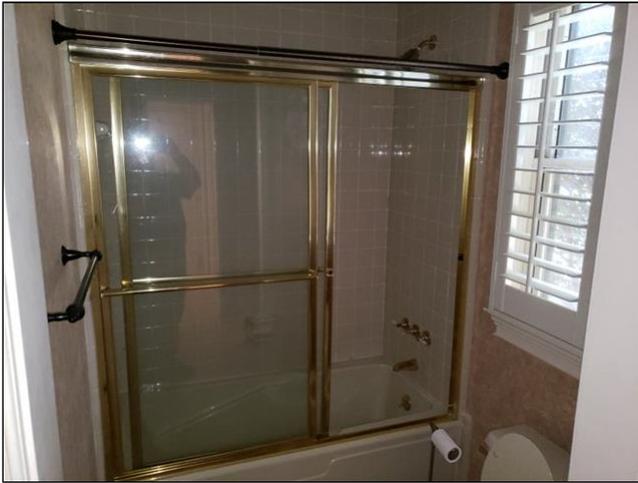
13.16 Item 1(Picture) guest house bathroom

13.16 Shower doors do not work properly. I recommend repair or replace as needed.

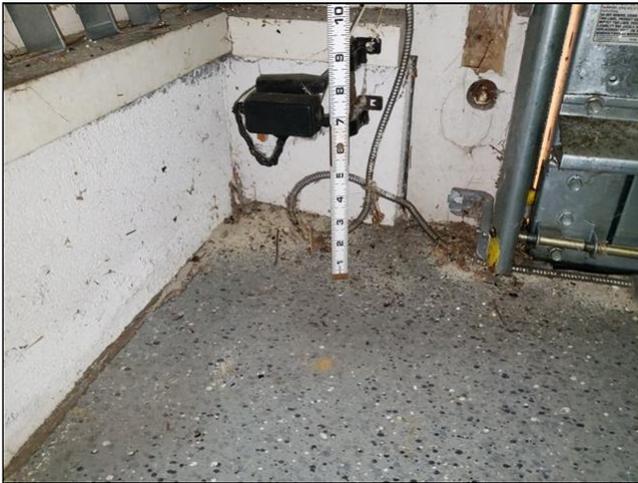
13.26 Item 1(Picture) guest house garage - door safety sensor

13.26 The automatic opener for garage door at the front of home has electronic sensors located higher than six inches off floor which is not installed according to accepted safety standards. This is considered unsafe and needs correcting. I recommend repair as necessary for safety.
